STAR MINE DAM

WASHINGTON COUNTY, MISSOURI

MO 31005

**PHASE 1 INSPECTION REPORT
NATIONAL DAM SAFETY INSPECTION**

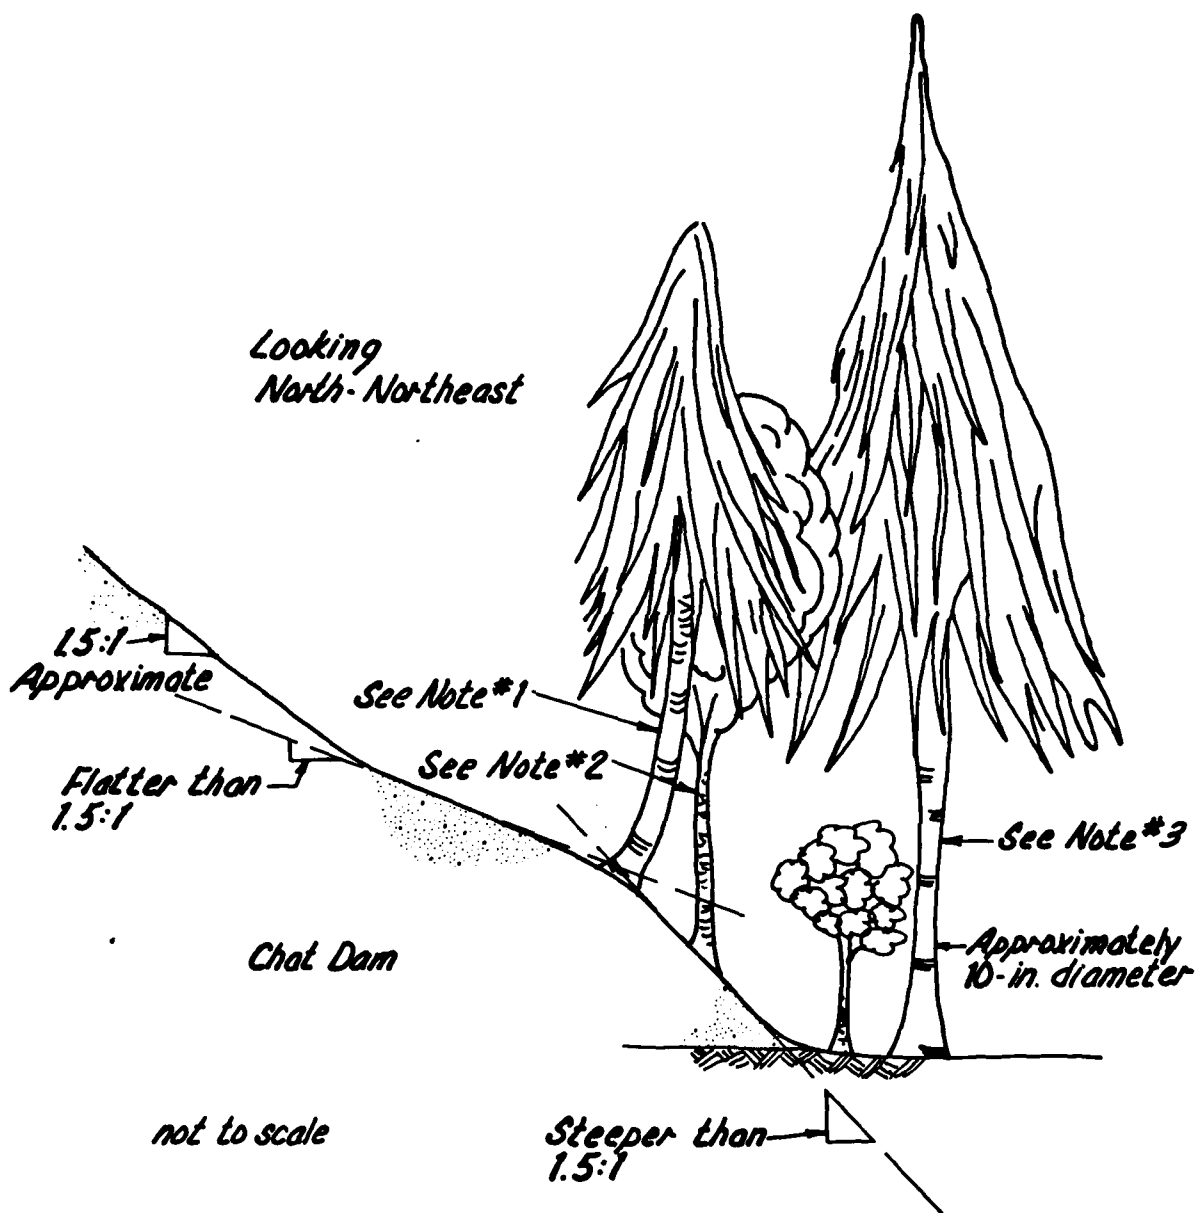
Fig. 5

1. Older trees on bulge are curved.
2. Younger trees on bulge are unaffected.
3. Both older and younger trees are unaffected at toe of Dam.

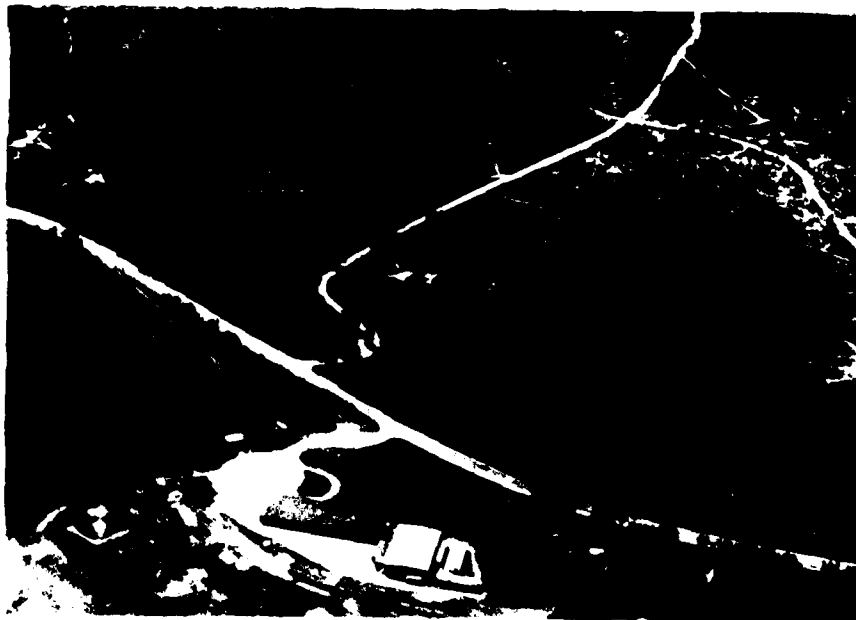
2. Downstream hazard - school; looking west.

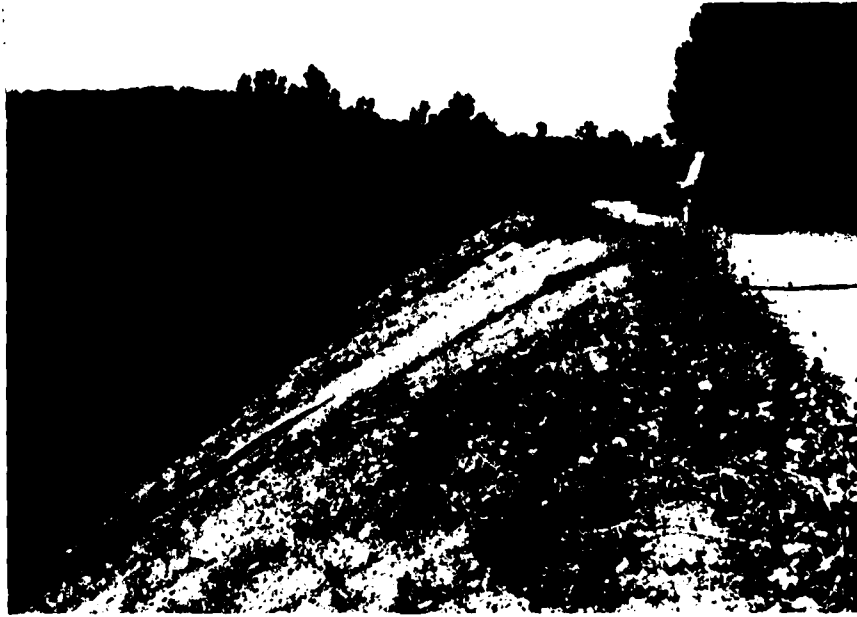
The crest of the dam had depressions or broad swales that would indicate that the embankment had settled (Photos 3 and 5). Without prior monitoring of the dam, however, this cannot be confirmed. One small possible slump scarp was noted on the downstream side of the dam crest. It is only a few inches deep and may possibly be a rut from vehicular traffic rather than a slump scarp (Photo 6).

3. Crest alignment, slope irregularities and vegetation of Star Mine Dam.
